## Property Inspection Report

**Inspection Site:** 1620 15th Street NW  
Washington , DC 20009

**Inspection Date:** 12/10/2008

**Inspected by:** **Claxton Walker & Associates**

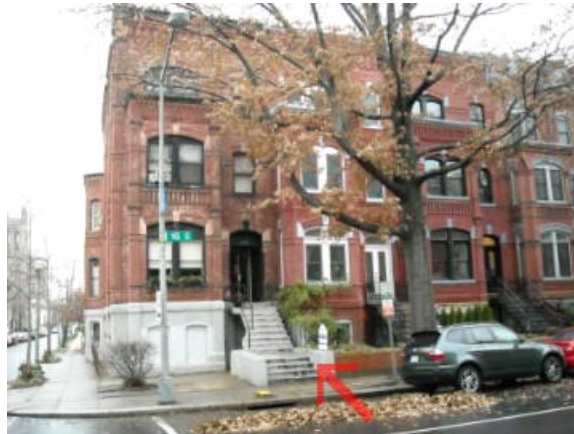
#### MAIN ENTRY STOOP

Appears sound. No problems were found. note: The front steps are painted. Painted steps are very slippery.

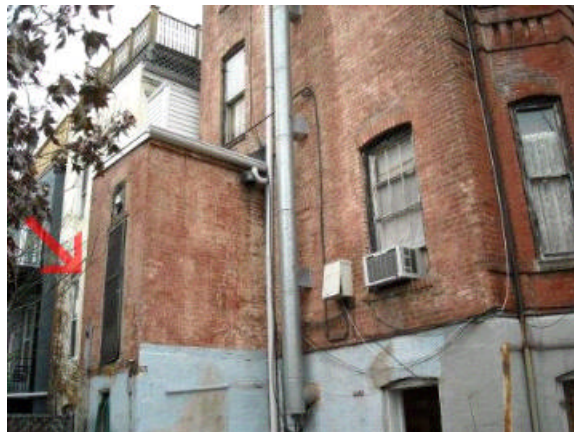
#### SECONDARY ENTRIES

First Level: No rear steps leading the main floor. Basement level: Water leaks into

basement at the rear door sill.

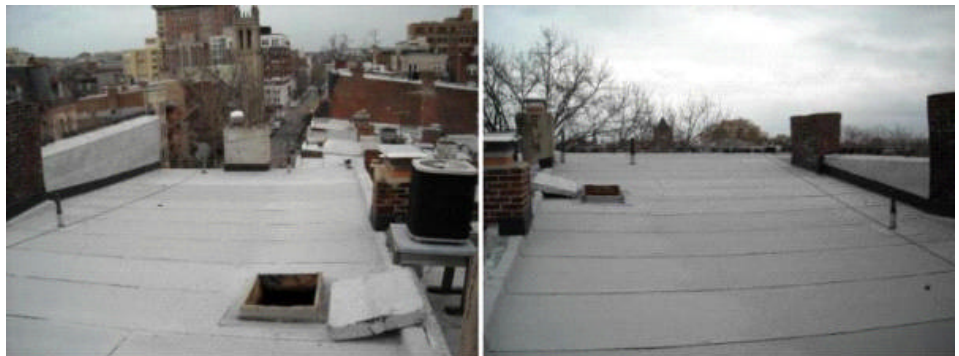
*MAIN ROOF CONDITION*

Good condition. Little or no wear and a long life expectancy.

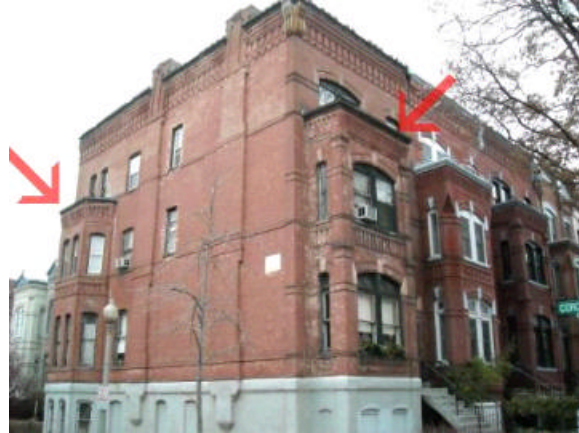
*SECONDARY ROOF CONDITION*

Both roofs need repair. Given their age anticipate replacement of both. There is active leaking at both bay windows inside . This roof is in poor condition. It needs replacement.

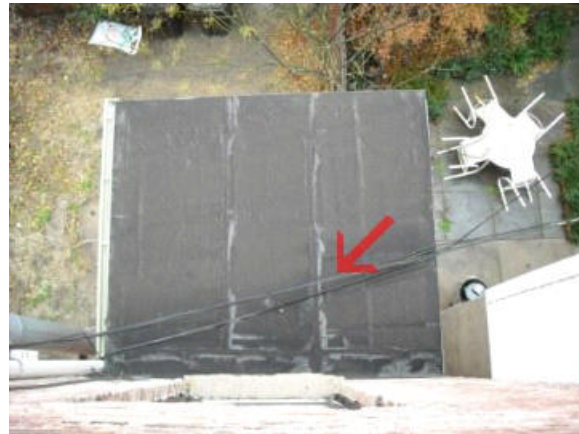
*THIRD ROOF CONDITION*

Generally satisfactory, normal wear, needs no repair at this time.

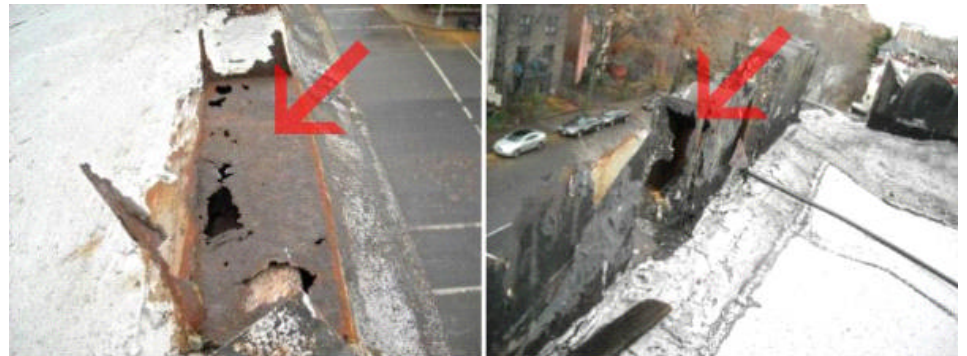
*FLASHING*

The decorative parapet flashing along the perimeter of the roof is rusted out . There are holes where water can leaking into the walls below. repairs needed. The roof access door is not water tight.

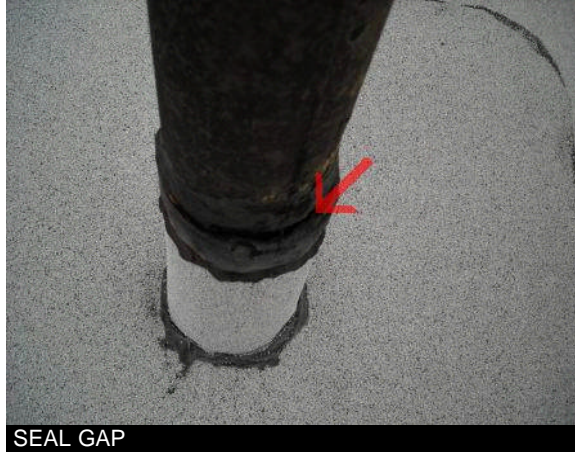
*VENTS and COLLARS*

1 Plumbing vent collar needs repair.

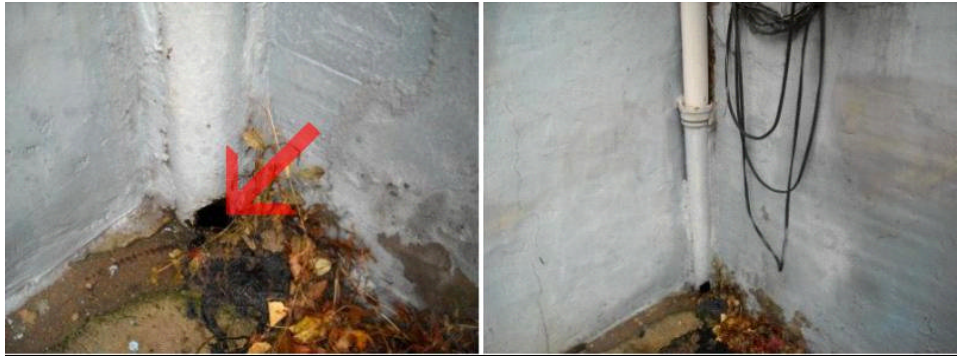
*MATERIAL TYPE and  
CONDITION*

clogged

The buried drain line at the rear downspout is clogged. The bay window downspouts are rusted and will need to be replaced when the bay roofs are replaced.

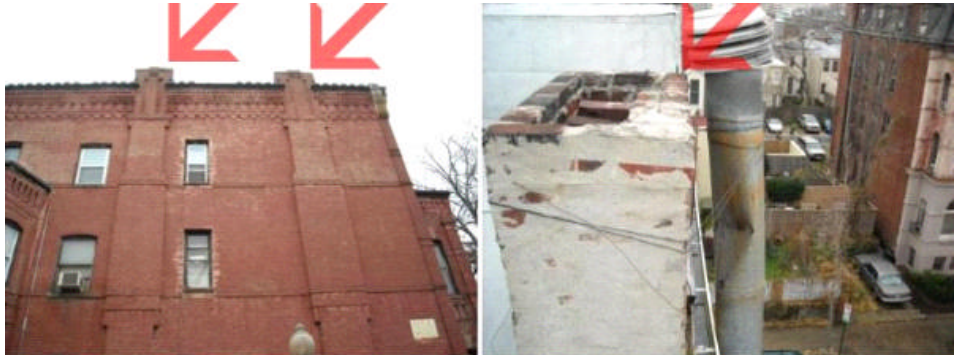
*MASONRY CHIMNEY TYPE and  
CONDITION*

Three chimneys. seven flues. The Chimneys are not in use and are not in a condition where they can be put in use. If you want to utilize the chimneys have a separate chimney inspection. None of the flues are lined. The chimneys need some repair in order to stabilize the deteriorating brick work around the tops. see photos.

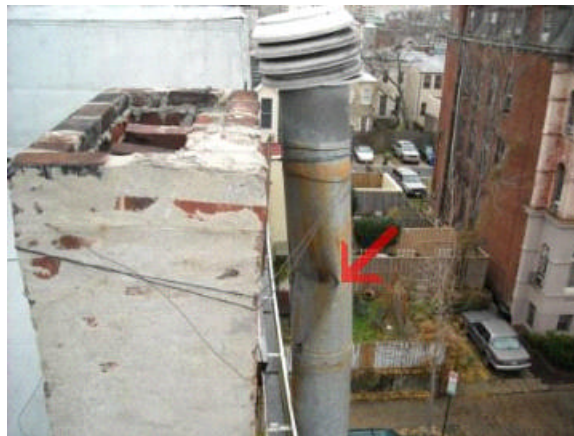
*METAL CHIMNEYS AND  
COMBUSTION VENTS*

The flue is bent and needs a strap to hold it straight, vertical and secure. It's tied with string to the brick chimney. The bent flue section should be replaced. The rain cap is dislodged.

The flue is bent and needs a strap the hold it straight, vertical and secure. Its tied with string the brick chimney. The bent flue section should be replaced. The rain cap is dislodged.

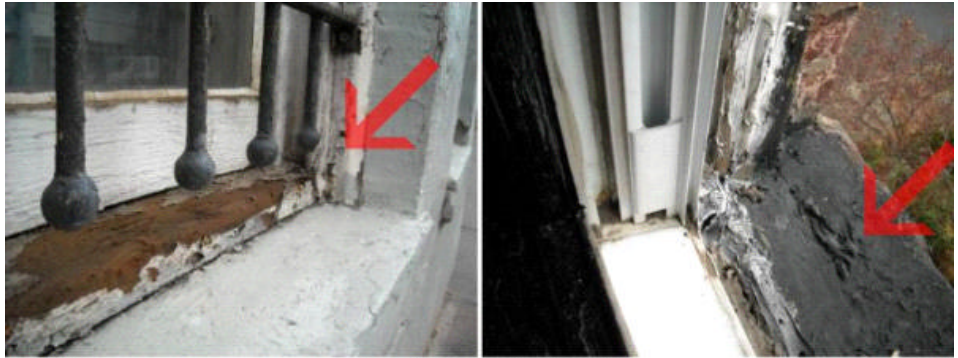
*CONDITION*

All the wood trim at the windows and doors is in bad shape.

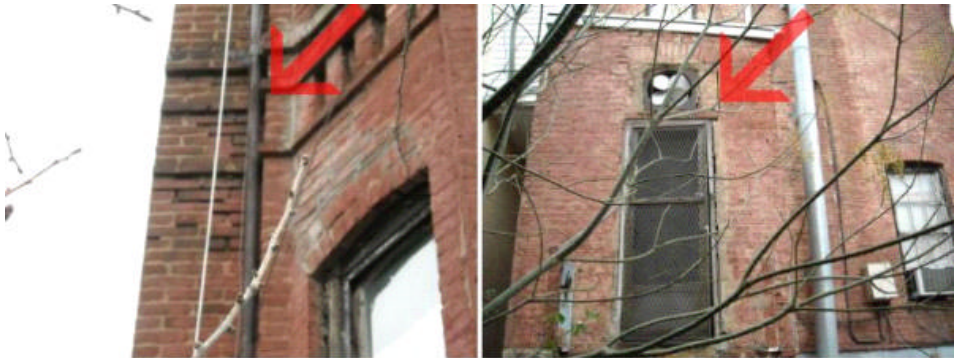
*CONDITIONS (exterior walls)*

The brick work at the rear kitchen addition needs repair. There is some sporadic tuck pointing that is needed at the side walls.

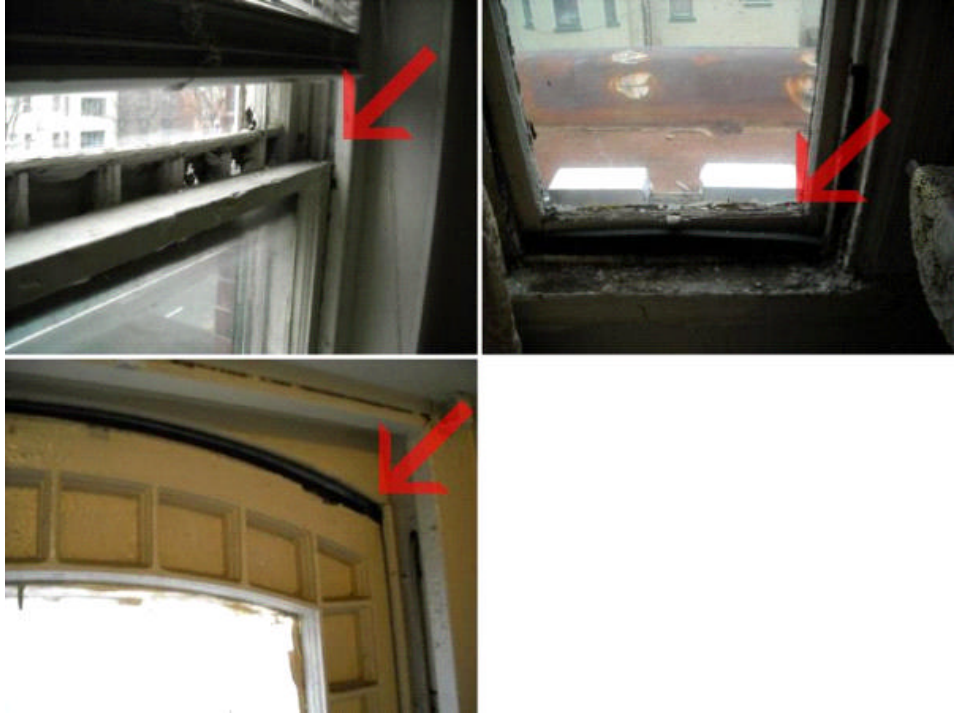
*WINDOW CONDITION*

A major amount of window restoration/repair/replacement is going to be needed. All were in poor condition.

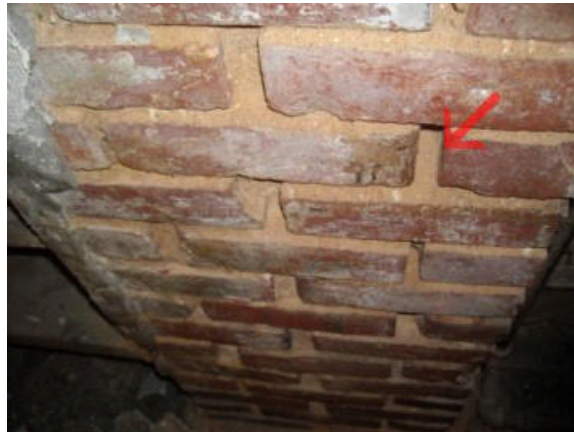
*FOUNDATION WALL CONDITION*

The walls with need significant tuck pointing on the interior after the plaster and drywall are removed. The mortar has turned to sand in places.

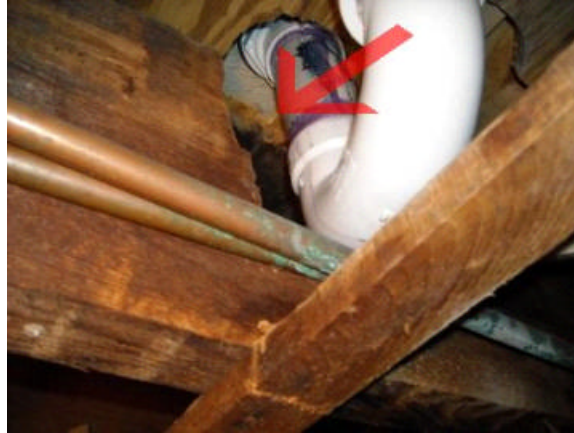
*MAIN FLOOR FRAMING  
CONDITION*

Generally satisfactory but some repair is recommended. There are some joist that were cut to accommodate changes in the plumbing. They need repair. I noticed a sag in the floor at the area around each bath . Rear north west quadrant of the house, around each bath area. Anticipate some shoring or joist repair when the baths are replaced.

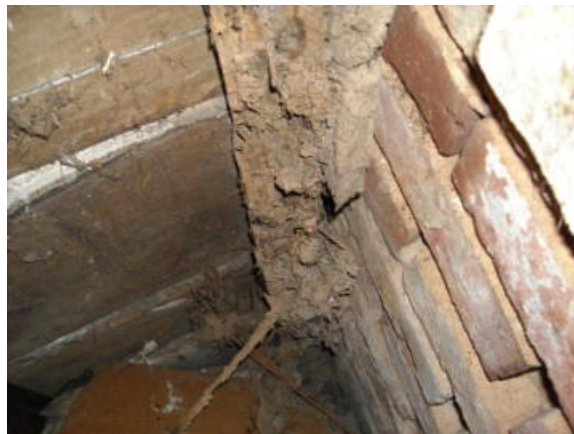
*INFESTATION SIGNS*

Hidden areas can't be assessed and insect infestation inspections are a specialty unto themselves. Many structural components are hidden in the finish so it is never possible to be 100% sure about termite conditions. Damage was observed. at the basement wall studs.

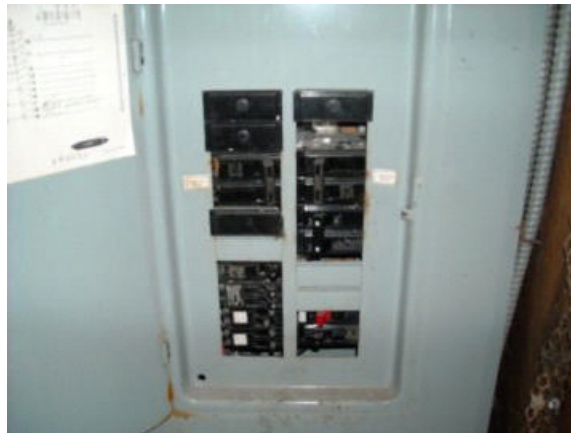
*REPAIR NEEDS IN THE MAIN PANEL(S)*

The panel mounting is loose. Screws for the panel cover are missing. Loose wires were found in the panel. The panel has knockouts that have been left open. Open knockouts should be covered for shock and fire protection. The box is supposed to be able to temporarily contain a fire or sparks. Needs to be replaced with individual services one for each condo.

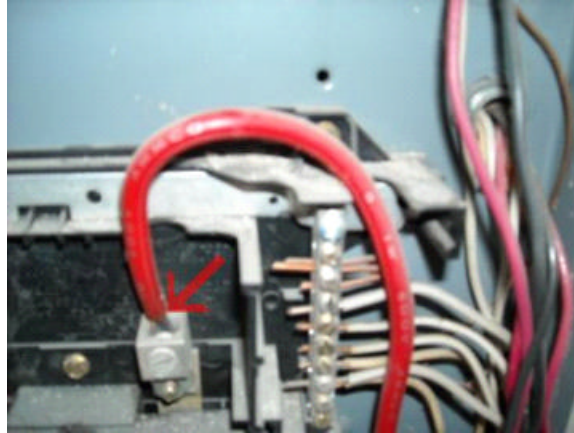
*REPAIR NEEDS IN THE  
SUBPANEL(S)*

Heat damaged wiring was observed in the panel.

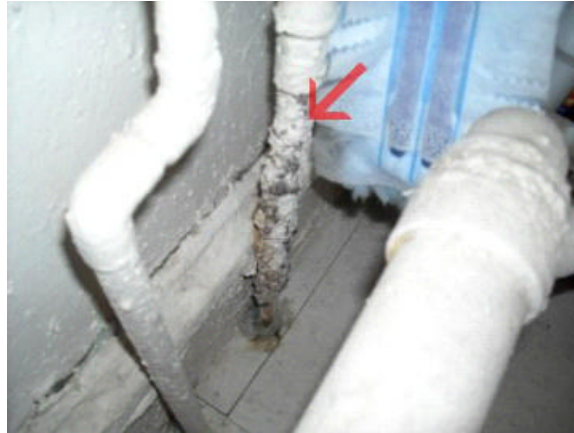
*INTERIOR SUPPLY PIPE  
CONDITION*

There are some rotted pipes. I anticipate the all the water and waste pipes will need to be replaced.

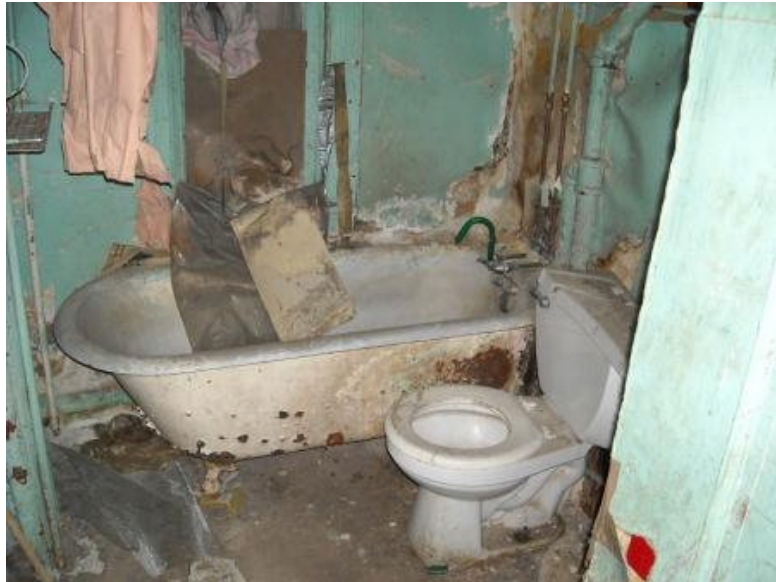
*PLUMBING DRAIN AND VENT  
CONDITION*

I anticipate the all the water and waste pipes will need to be replaced.

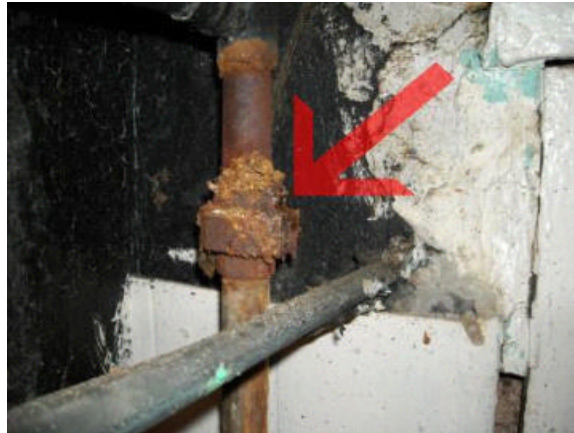
**7.7 FUEL PIPES, OIL TANKS**  
GAS

NUMBER OF METERS: One. LOCATION OF METER(S): On the left side of the house outside. GAS LEAK DETECTED: At the water heater piping.

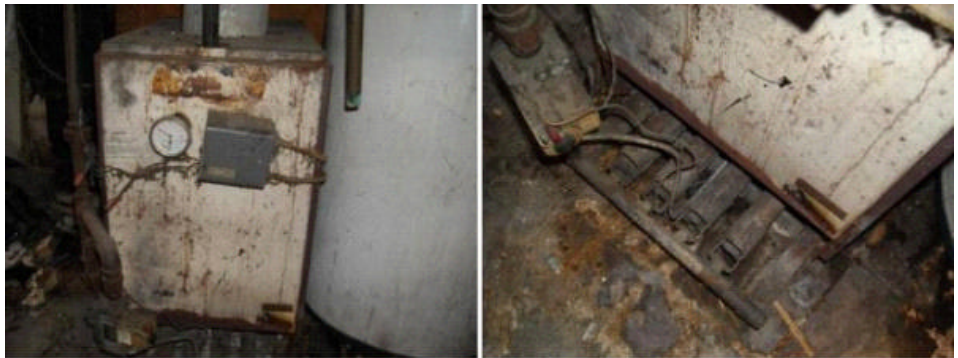
GENERAL CONDITION (Unit #1)

Unsatisfactory. It is recommended that the unit be replaced either now or very soon. This system won't be suitable for the building if it is renovated. Consider individual systems for each unit.

Unsatisfactory. It is recommended that the unit be replaced either now or very soon.

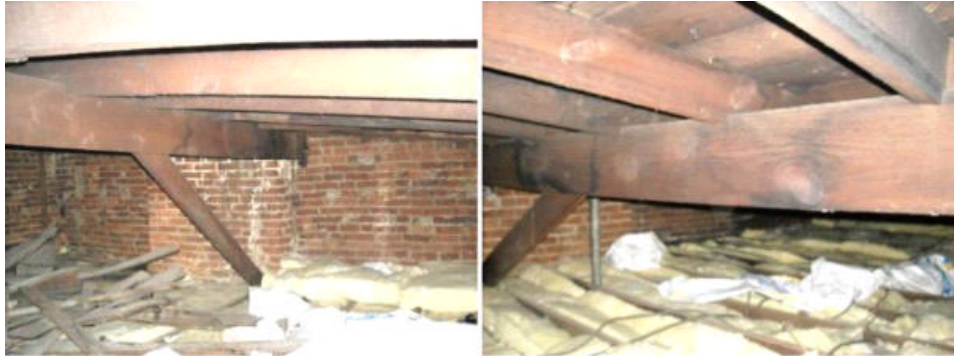
*ATTIC STRUCTURE CONDITION*

Satisfactory. No major problems noted. Materials and methods are commensurate with expected standards.

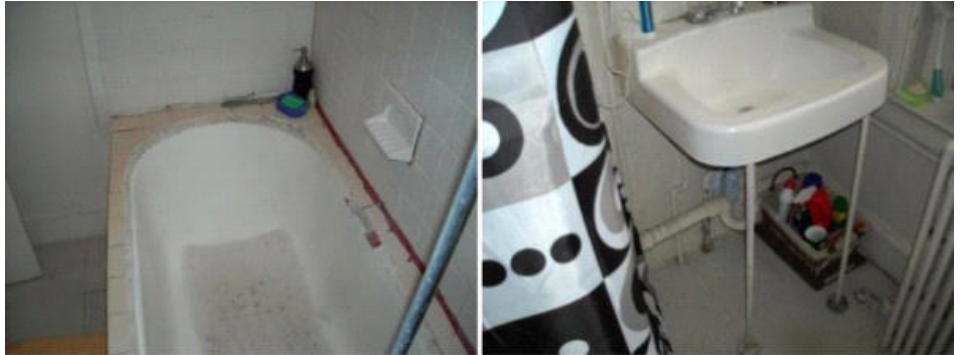
*GENERAL CONDITION*

All the baths will need renovation. Due to wear , general quality.

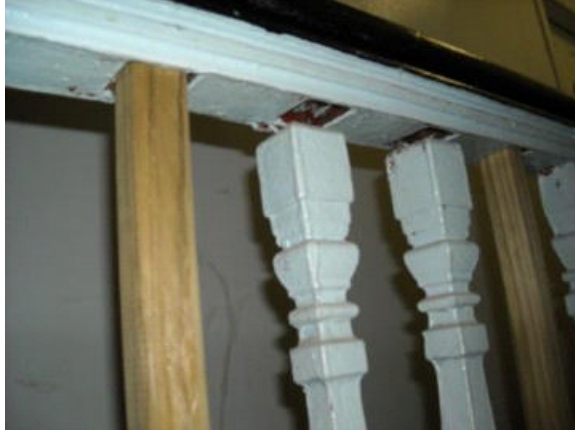
*TREADS AND RISERS*

The stairs are narrow. The upper stairs are being supported by an added cross brace.

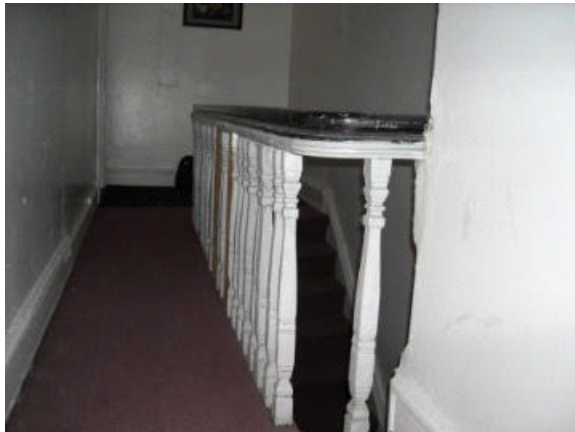
*BALUSTRADES AND RAILINGS*

The railing is broken. The balustrade is loose. The rails are too low, not child safe, have broken and loose picket. Rebuilding the rail is needed.

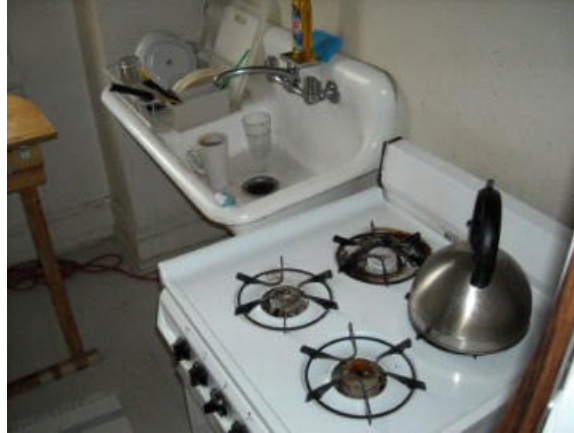
#### *GENERAL KITCHEN CONDITION*

Inadequate electrical layout. All kitchens need modernization.
