# **STRUCTURAL SURVEY**

**1620 15<sup>th</sup> Street, NW  
Washington, D.C.  
SK&A #208-068**

**December 12, 2008**

RE: Structural Survey  
1620 15<sup>th</sup> Street, NW  
Washington, D.C.

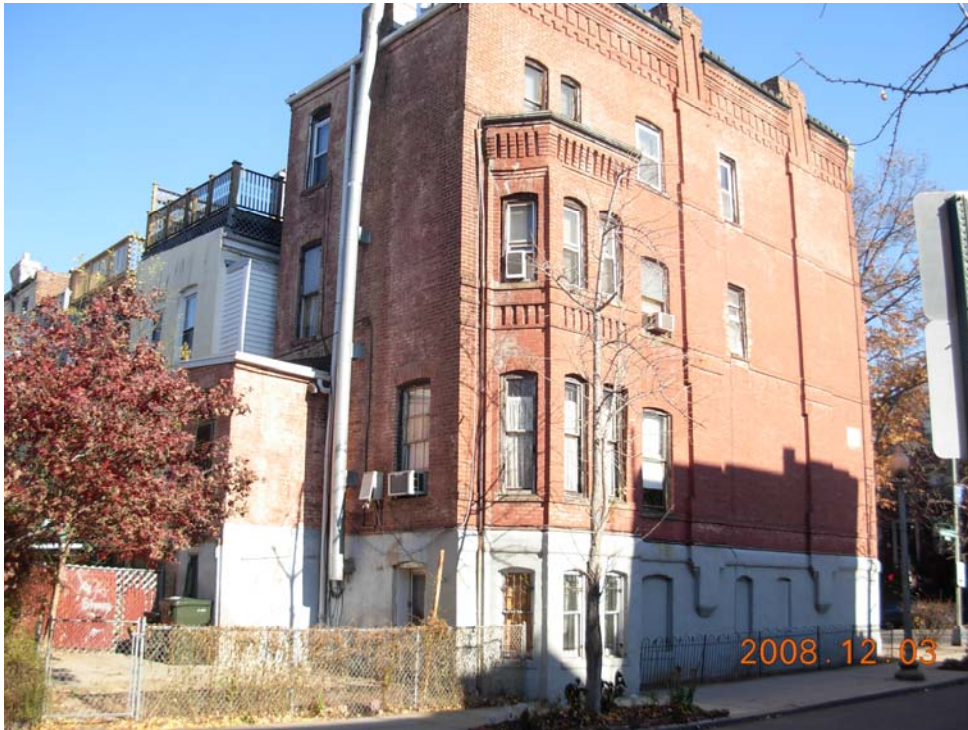
Photo 1: South wall west end bay window

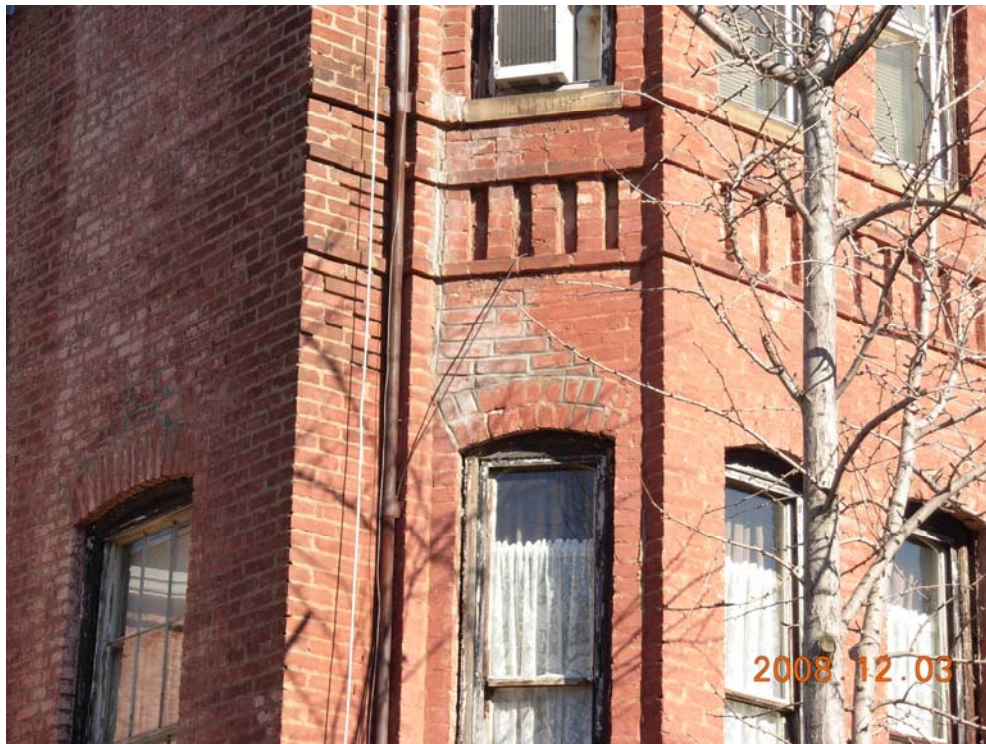
Photo 2: Step cracking, previous patchwork and deteriorated mortar at southwest bay window

2. Brick façade: masonry shall be high-pressure surfaced to remove loose mortar, then re-pointed and sealed or painted to protect against future deterioration. While floor framing is exposed, supporting members and lateral connections at bay windows shall be inspected. Possible thru-bolting with exterior star anchors may be necessary to restrain buckling of masonry wall. Joists supporting bay floors may need additional anchoring back into main floor joists. Where new window openings are desired on south wall, proper lintels shall be installed to support brick and transfer bearing load around opening.

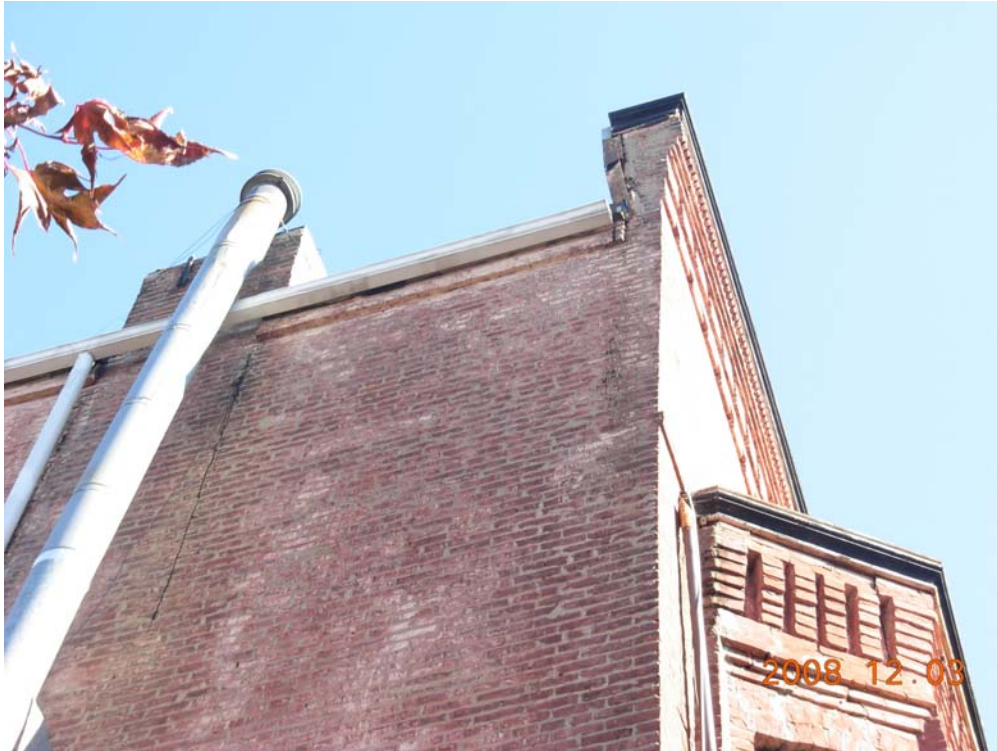
Photo 3: Masonry parapet at southwest corner

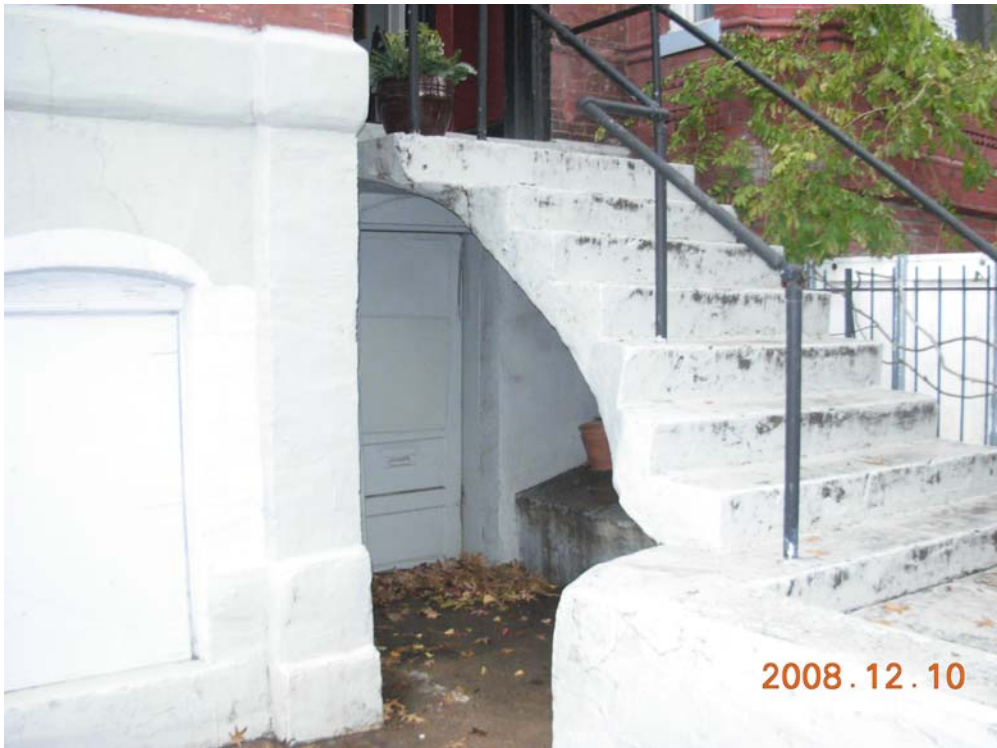
Photo 4: Concrete stair at front entrance

4. Stairs: interior stairs and handrail shall be repaired or rebuilt to be structurally sound and support code design live loads. Stair width and handrail height may also need alteration to meet current architectural life safety code requirements. Exterior concrete stair shall be high-pressure surfaced. If cracks are visible, they shall be injected with pressure epoxy-grout. Concrete should then be sealed or painted to protect against future deterioration. Upper floors have only one means of egress (main front entrance). Options should be explored for providing second egress, as per architectural life safety code requirements.

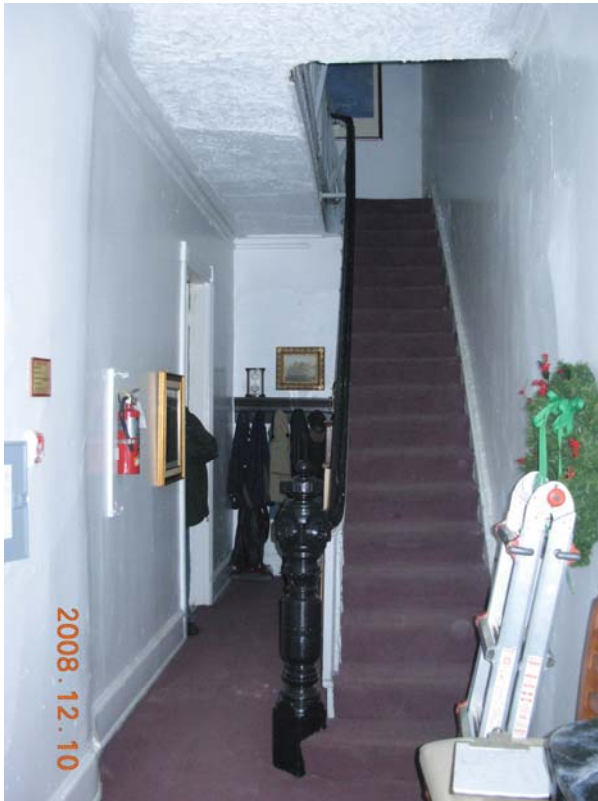
Photo 5: Interior staircase at first floor

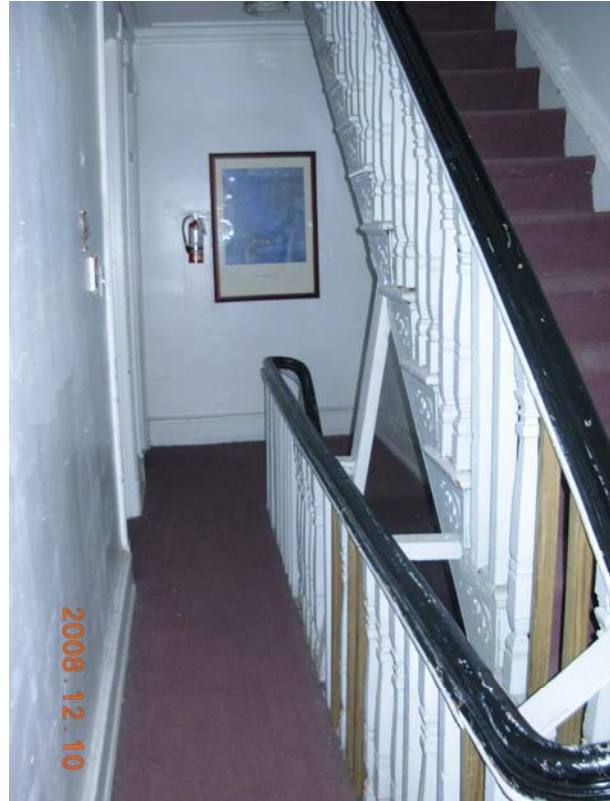
Photo 6: Handrail at third floor with previous repairs

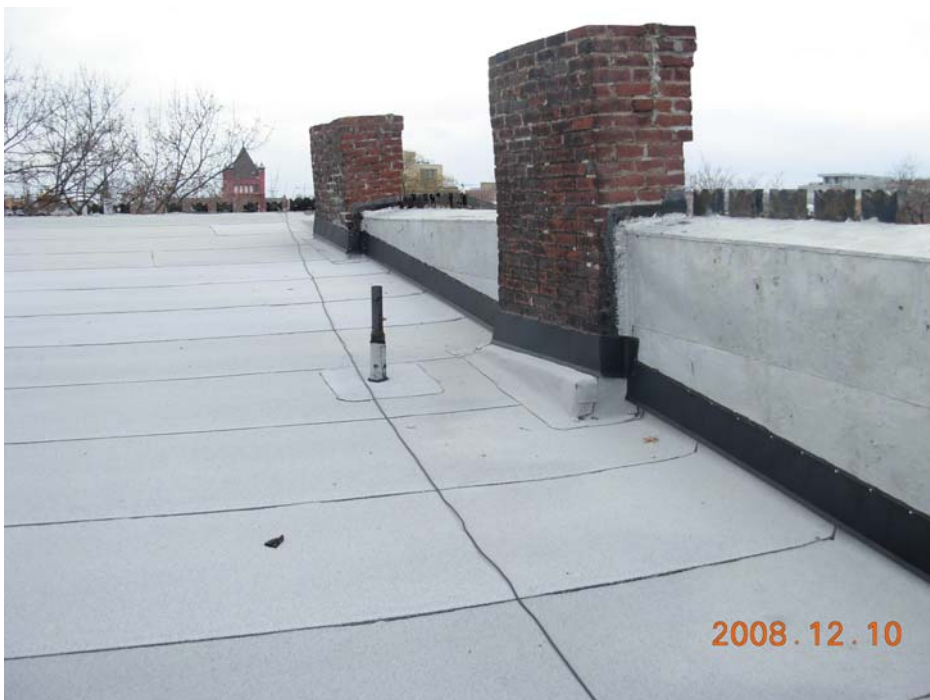
Photo 7: Roof, chimneys, parapet with partially deteriorated metal scallops

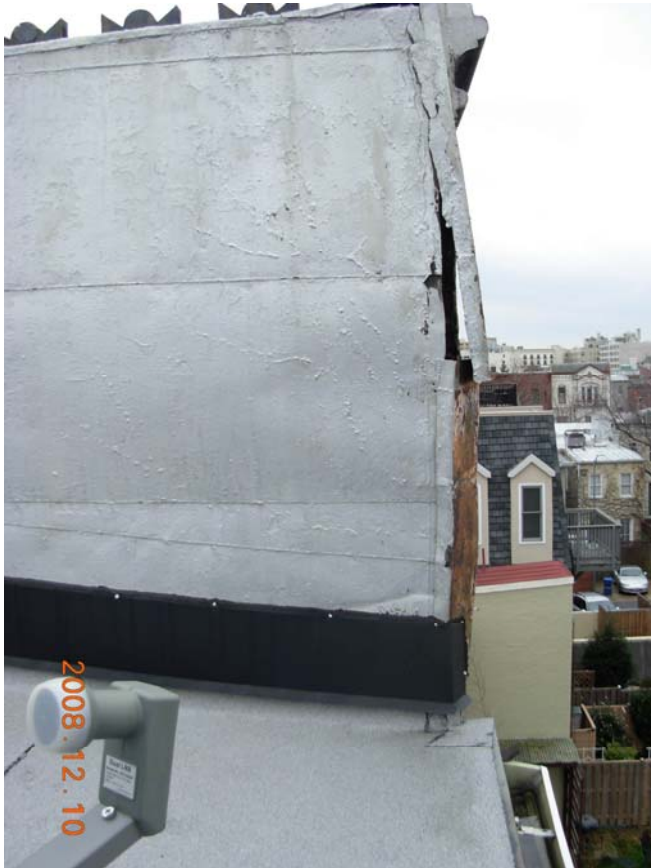
Photo 8: Roof parapet with deteriorated metal sheathing

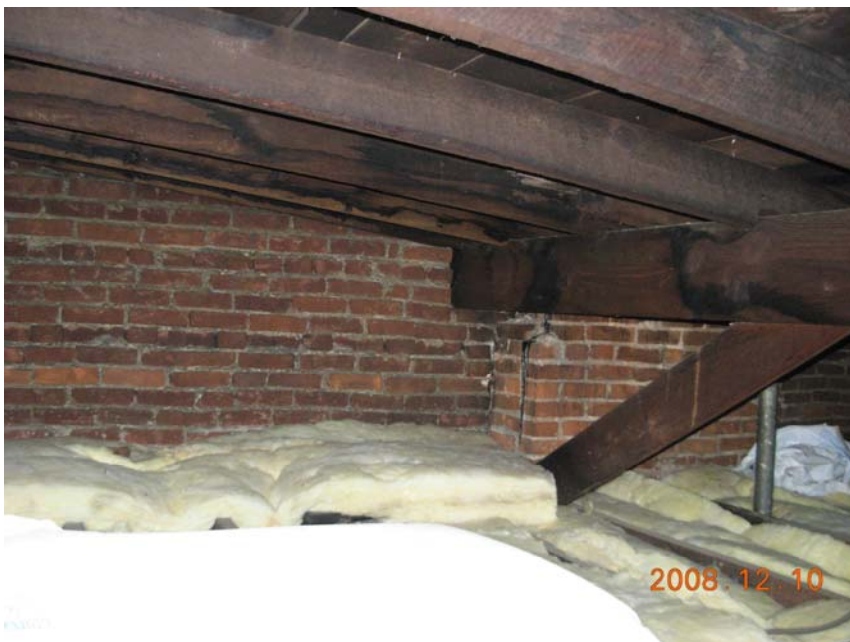
Photo 9: Attic and roof framing
